Earthquake-induced habitat migration in a riparian spawning fish: implications for conservation management

Galaxias maculatus is a riparian spawning fish that supports an important recreational fishery in New Zealand with spawning habitat requirements strongly structured by salinity gradients at rivermouths. This study reports changes to the spawning habitat following a series of large earthquakes that resulted in widespread deformation of ground surfaces in the vicinity of waterways. Assessments of habitat recovery focussed on two rivers systems, the Avon and Heathcote, with pre-disturbance data available over a 20 year period. Recovery dynamics were assessed by field survey and mapping of spawning habitat prior to and on seven occasions after the disturbance event. Riparian land-use and management patterns were mapped and analysed using overlay methods in GIS. Habitat migration of up to 2 km occurred in comparison to all previous records and several anthropogenic land uses have become threats due to changed patterns of co-occurrence. Incompatible activities now affect more than half of the spawning habitat in both rivers, particularly in areas managed for flood control purposes

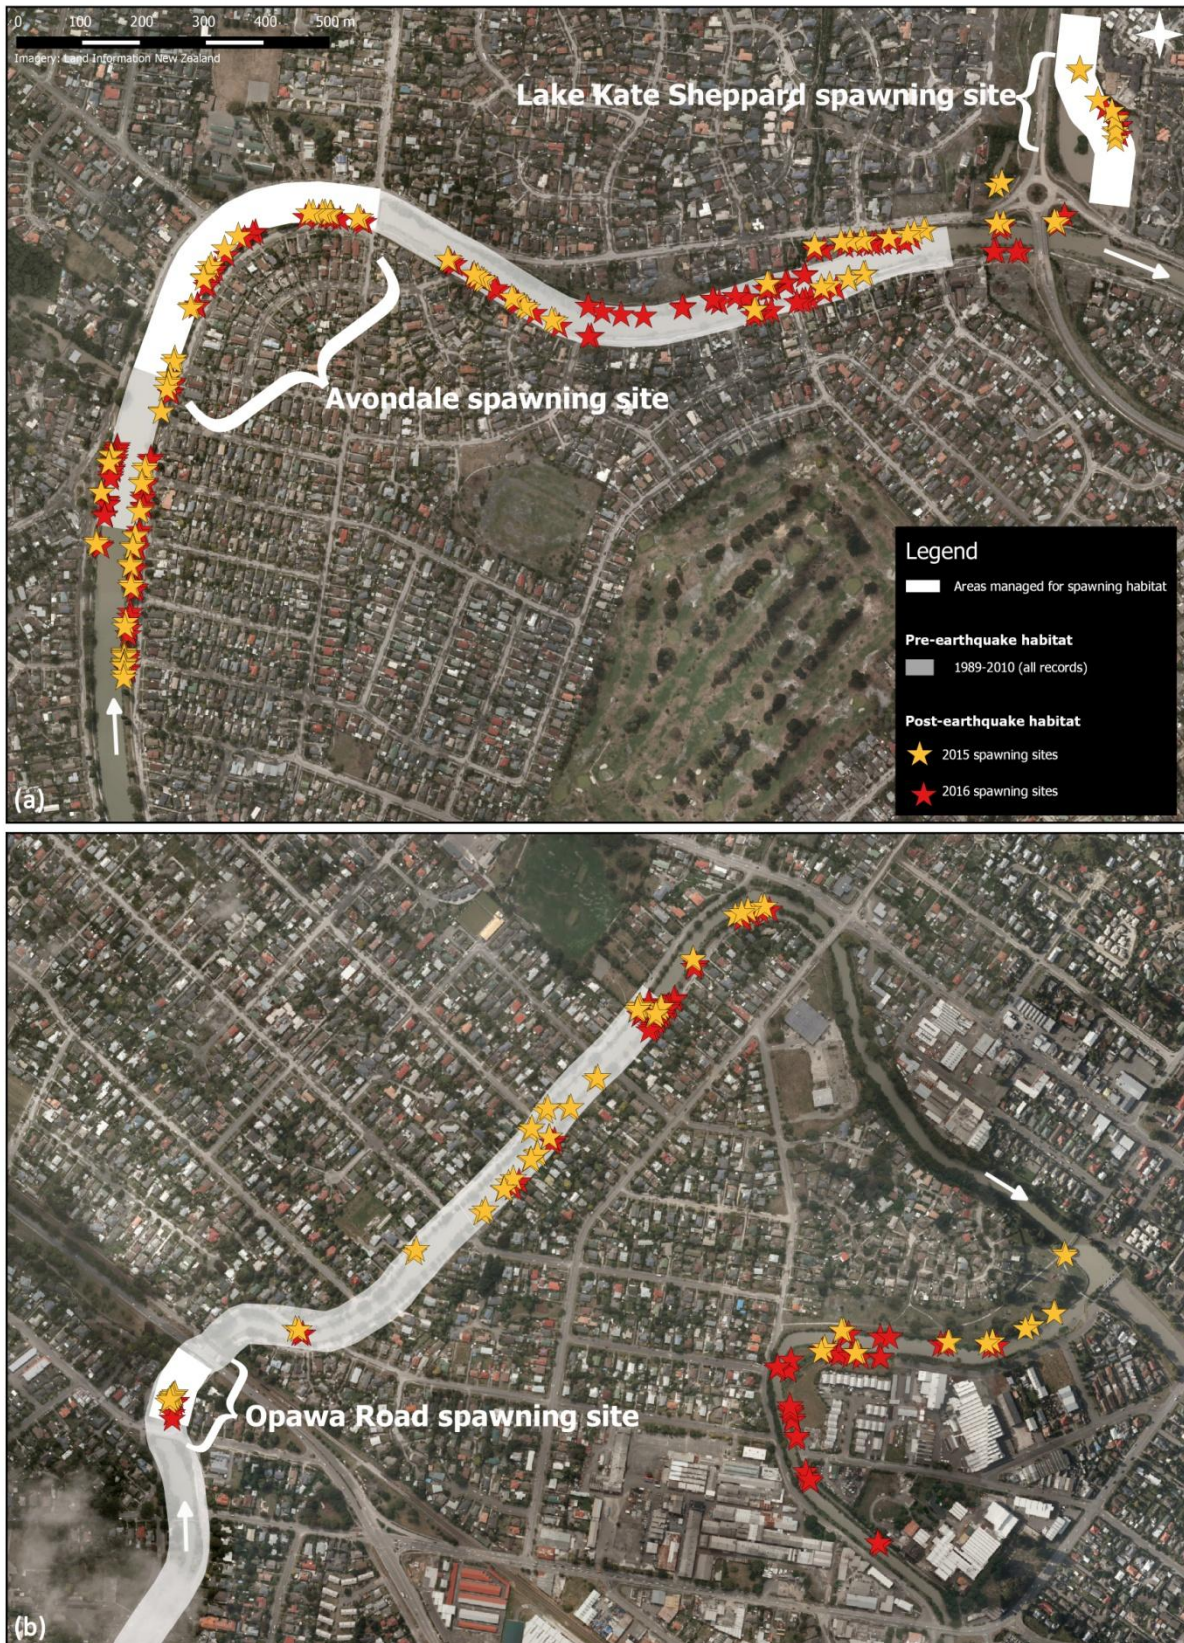
Figure 2. Post-quake inanga spawning distribution overlaid on the maximum pre-quake extent of spawning from all known records. Well-known pre-quake spawning sites are shown. (a) Avon River (Ōtākaro). (b) Heathcote River (Ōpāwaho).

A total of 85 spawning sites were identified in the 2015 post-quake survey. These were distributed along 2.4 km of riverbank in the Avon and 2.5 km in the Heathcote. In both rivers there were marked differences in the spawning distribution in comparison to previous records (Figure 2). In the Avon, the spawning reach had expanded approximately 250 m upstream and 180 m downstream of the previous extent. In the Heathcote, the changes were more pronounced with spawning recorded 1.5 km downstream of all previous records (Figure 2a). The 2016 survey identified a total of 101 spawning sites, some of which represented repeat use of 2015 sites. In the Avon, the upstream and downstream limits were very close to those recorded in 2015. In the Heathcote, the upstream limit was also similar to 2015, but the spawning reach extended a further 400 m downstream (Figure 2b).

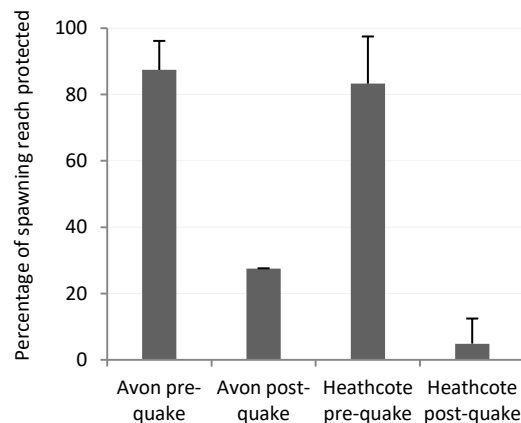
Figure 6. Percentage of the known *īnanga* spawning reach in protected areas in the Avon and Heathcote rivers before and after the 2010–11 Canterbury earthquake sequence. Error bars are standard errors of the mean for the periods.

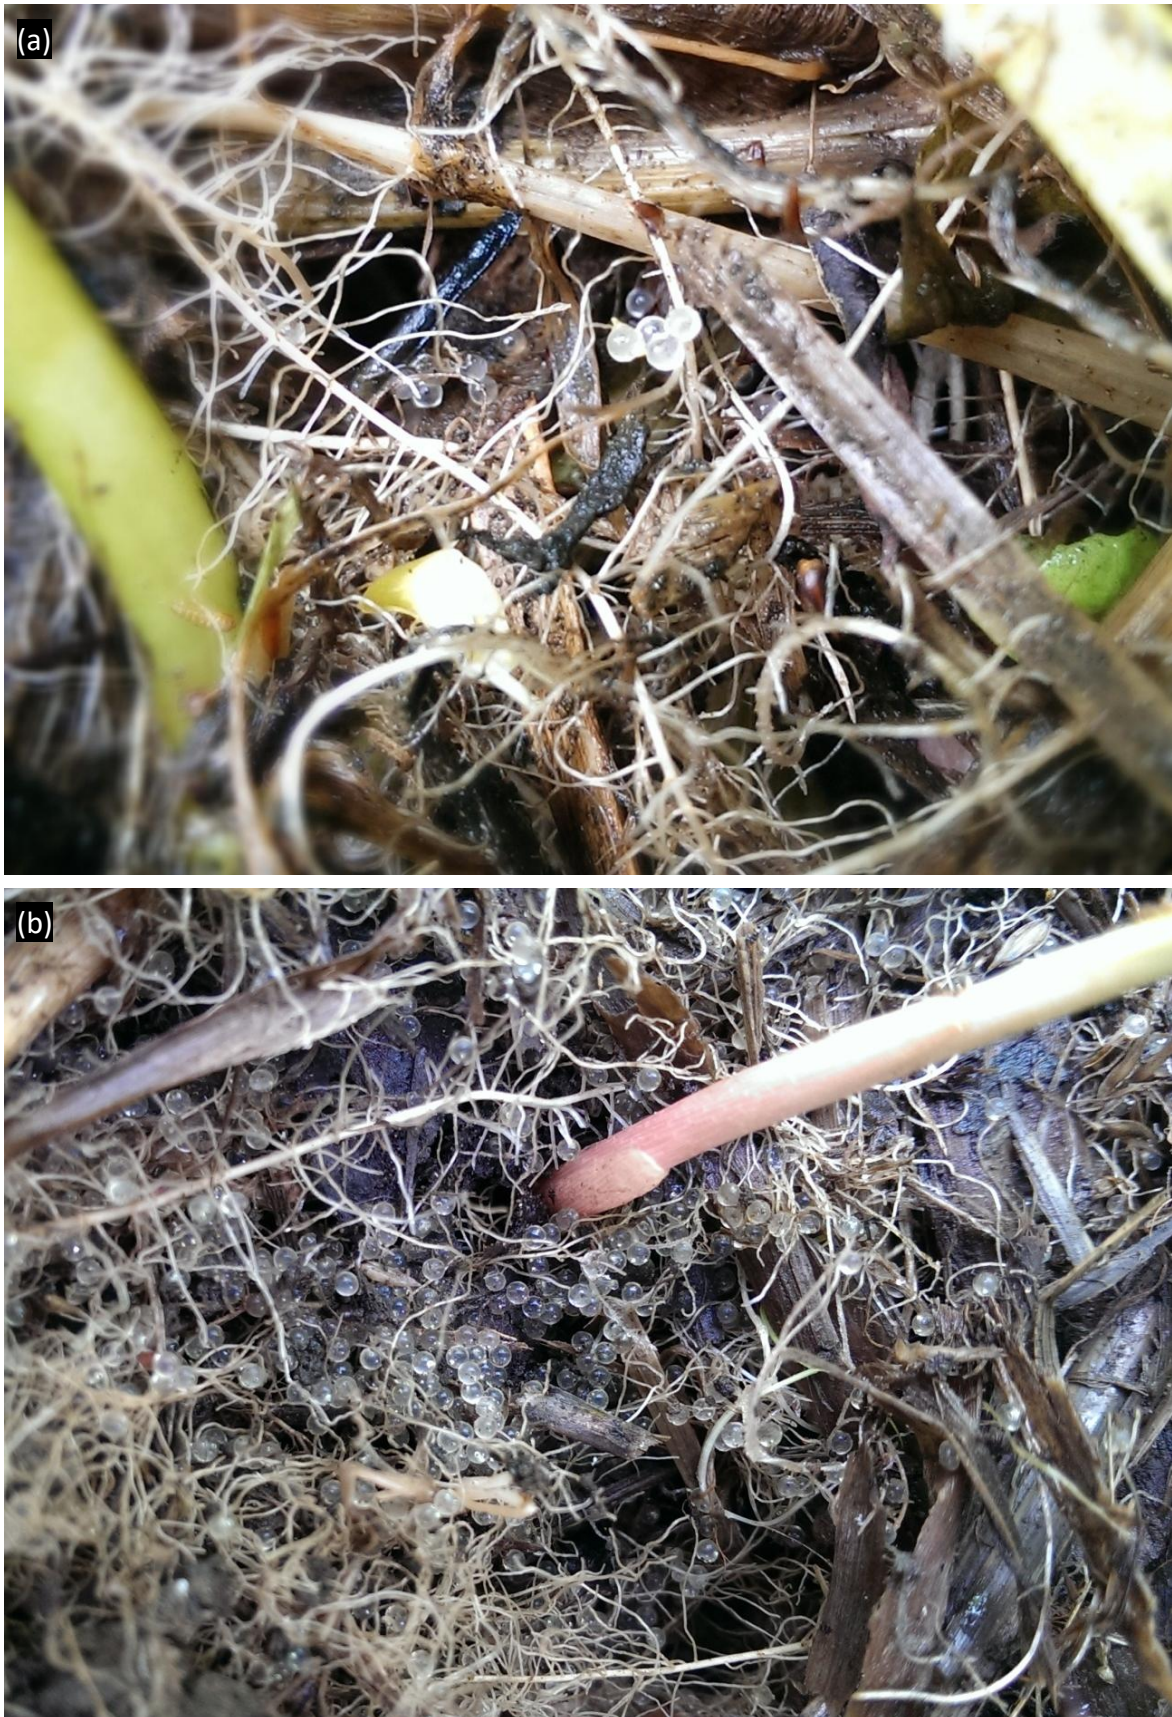
Figure S1. (a) *G. maculatus* eggs laid in riparian vegetation in the Heathcote River, February 2015. Each egg is approximately 1 mm in diameter. (b) An example of high egg densities at the Avondale site in March 2016.

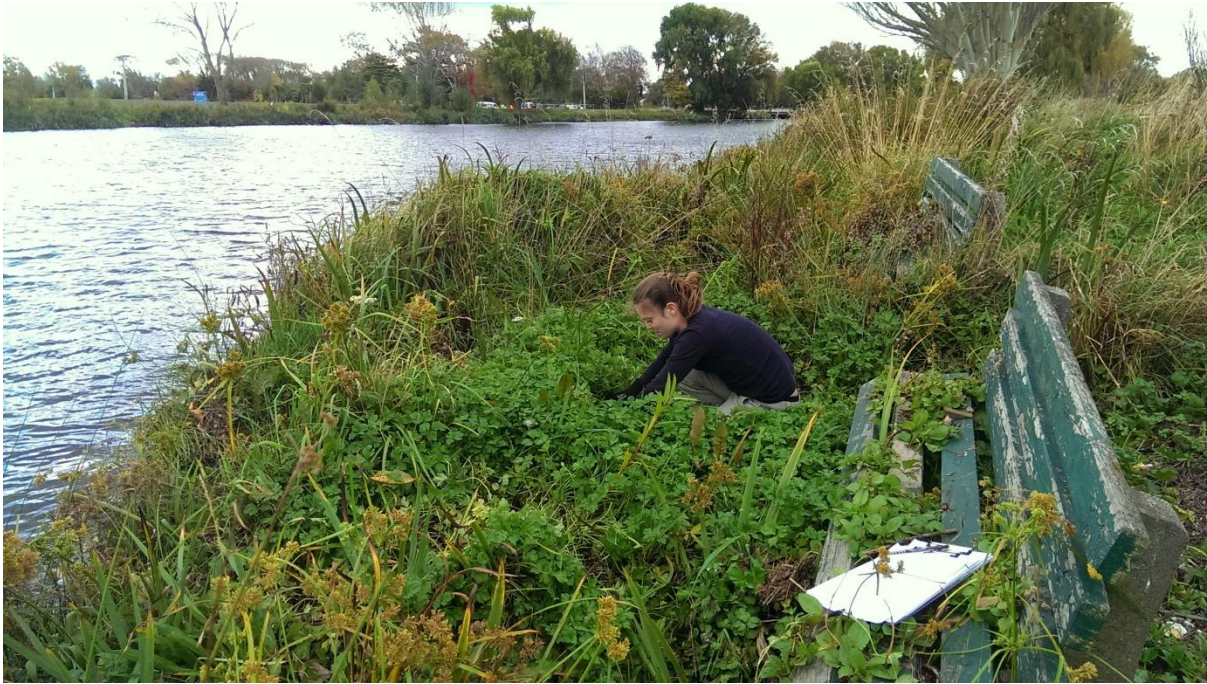
Figure S2. An example of good quality spawning habitat in the Avon River. In this part of the catchment ground levels had dropped by approximately 0.5 m as result of earthquake-induced subsidence and lateral spread. Prior to the earthquakes these overgrown park benches were considerably closer to the waters' edge.

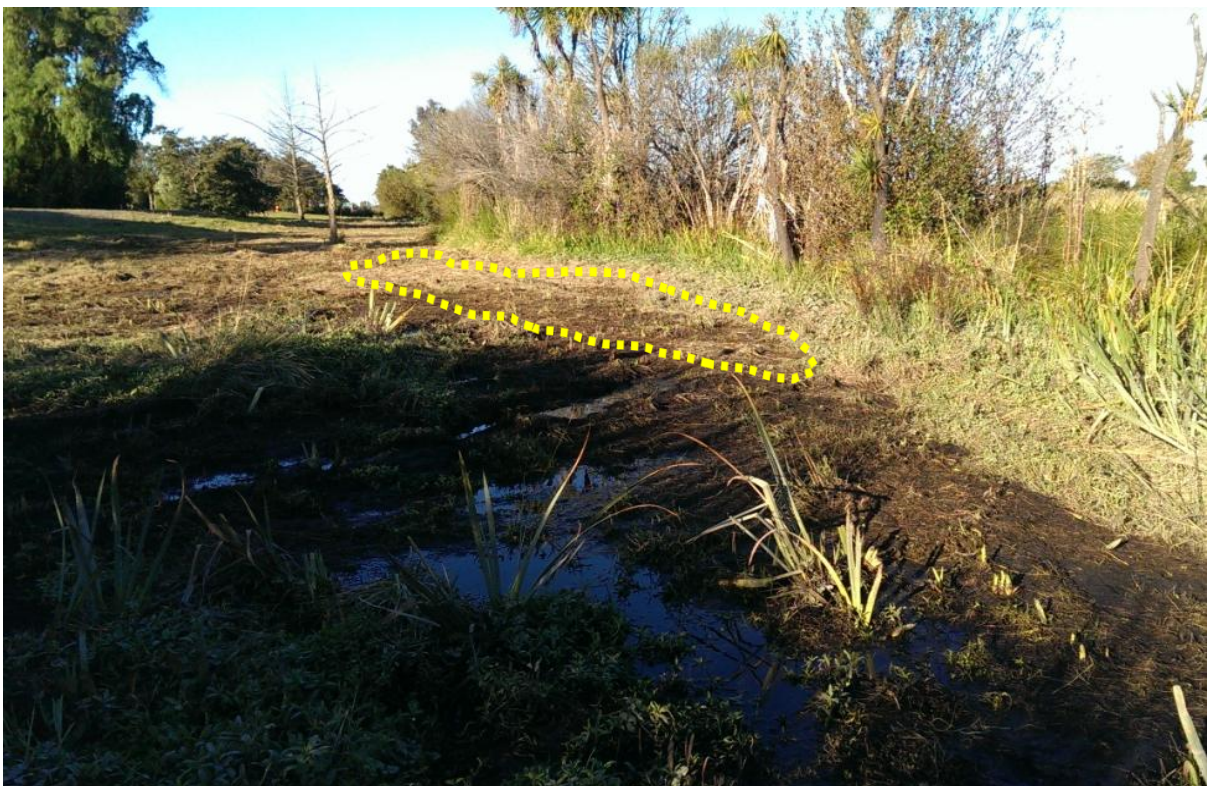
Figure S3. Example of a spawning site affected by mowing in a recreation reserve in the Avon catchment. The dotted line shows the area of occupancy (AOO) prior to mowing in March 2015. Egg mortality is close to 100% in these situations.

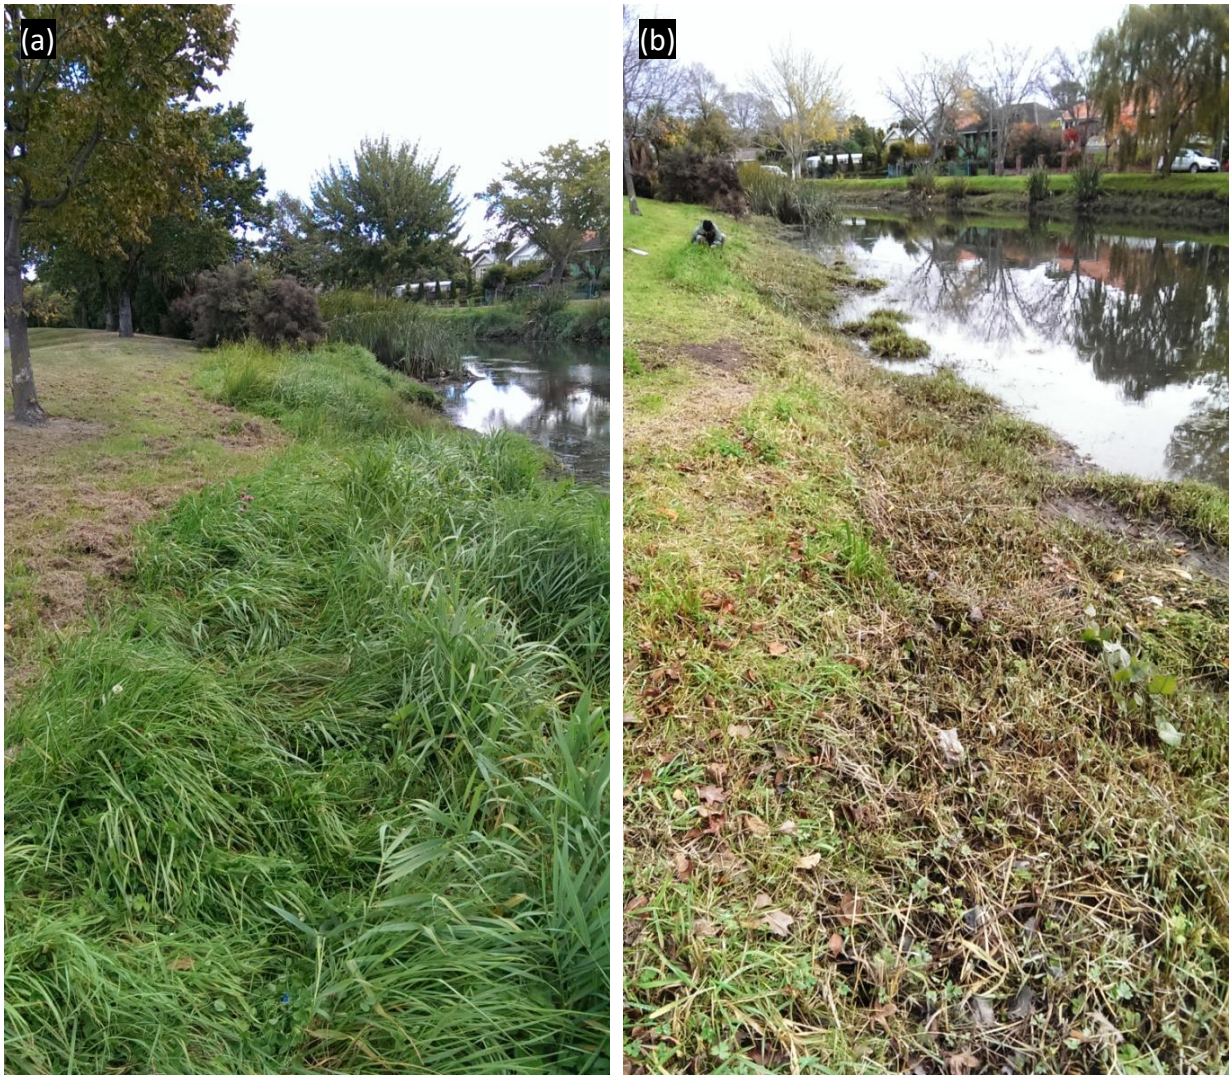
Figure S4. Example of vegetation clearance for flood management. (a) Spawning site in the Heathcote River in March 2015 at which 118,000 eggs were present (located in the long grass). Mowing of a recreation reserve can also be seen in this image but did not affect the majority of the spawning site which was located lower on the bank face. (b) The same site in early May 2015 showing typical conditions following clearance of vegetation for flood management using line trimmers. This management regime is regularly applied to a large proportion of the study area.
